Subject: EPA Comments on Kansas City Board of Public Utilities, Nearman Creek Power Station, Kansas City, KS
Round 7 Draft Assessment Report

**Subject: Comments on Draft Coal Combustion Waste Impoundment Round 7 –
Dam Assessment Report (Site #009), Nearman Creek Power Station,
Coal Ash Pond Dike, Kansas City Board of Public Utilities, Kansas City,
Kansas**

Coal Combustion Waste Impoundment Round 7 - Dam Assessment Report (Site #009)

Nearman Creek Power Station
Coal Ash Pond Dike
Kansas City Board of Public Utilities
Kansas City, Kansas

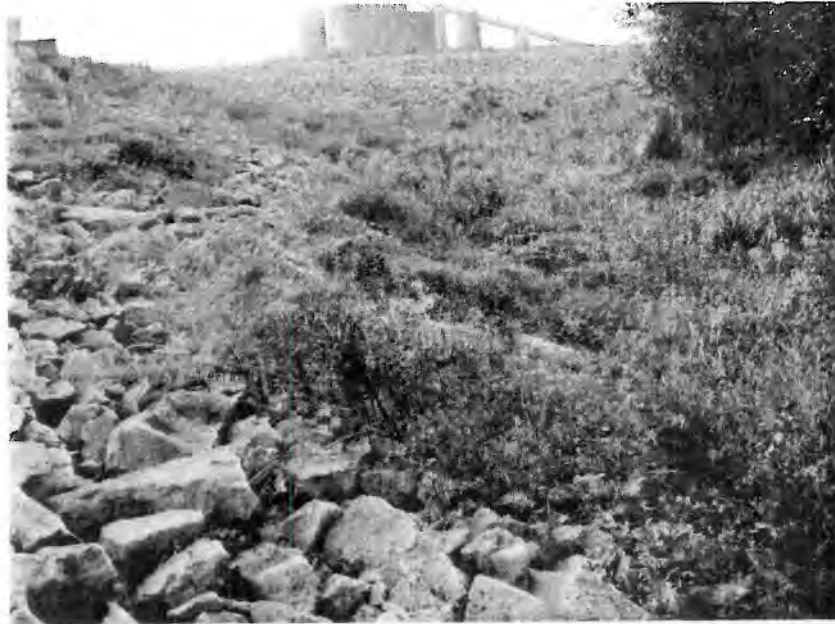
Heavy vegetation along the northern slope made access and visual observation difficult, but there were no obvious areas of seepage or soft soils along the toe of the down-gradient slope.

Figure 5.2.3-3: Photo of Outside Embankment Toe – North side of ash pond dike looking west.

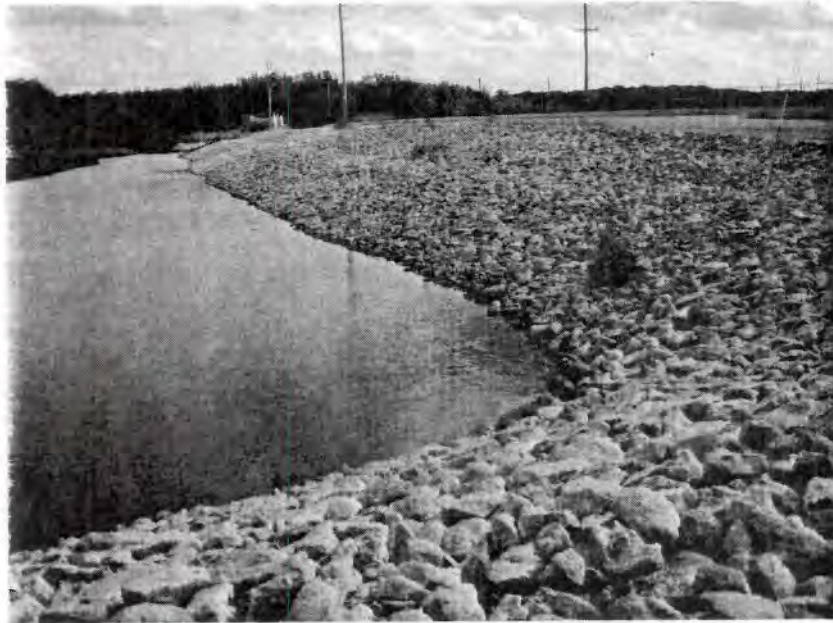
Neither erosion nor uncontrolled seepage was observed along the groins or abutments. Groin slopes and abutments are protected with the same rip rap cover as the adjoining slopes. Figures 5.2.4-1 and 5.2.4-2 show typical conditions observed at the groins and abutments.

Rip rap had been recently added and appeared in good condition.

Figure 5.2.4-1: Photo of Interior Groin at Northwest Corner of Impoundment. Note that the dike in upper right hand corner also serves as the flood prevention dike for the plant.

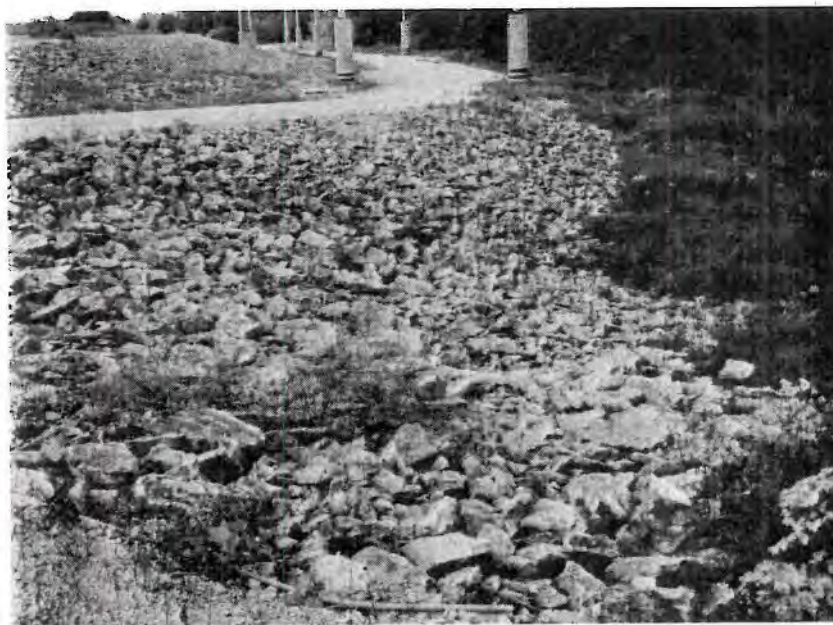
Figure 5.2.4-2: Photo of Exterior Groin at Northwest Corner of Impoundment. Note that the dike in upper left hand corner also serves as the flood prevention dike for the plant.

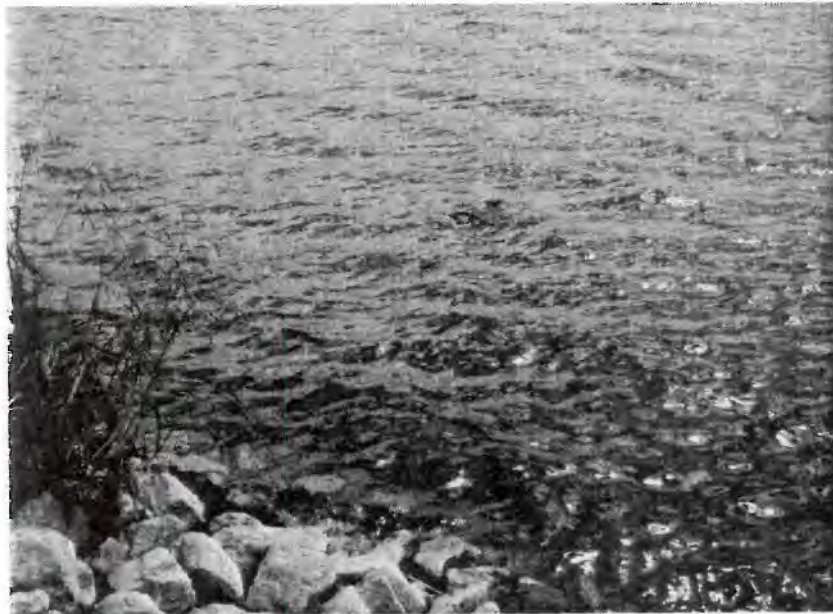
The original design included a 30-inch mid-depth discharge pipe regulated with a mechanical gate. The purpose of this pipe was to permit inflow into the pond in case of flooding to help stabilize the embankments during construction and prior to operational start-up. This pipe has reportedly been closed since construction of the pond was completed. When the mechanical gate started leaking, plant management decided to close this pipe using an inflatable balloon system. However, a small amount of leakage was observed from this pipe during the site visit, raising questions regarding the reliability of these closure mechanisms.

Figure 5.3.1-1: Photo of Mechanical Gate on Discharge Pipe in Interior of Ash Pond

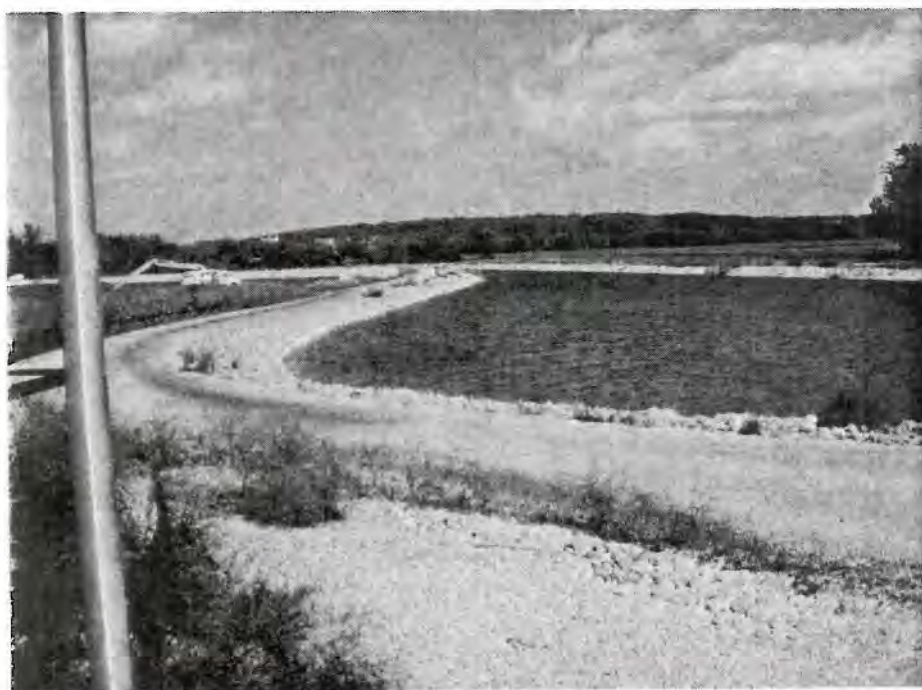
The facility is operated for the settlement and storage of wet bottom ash. Coal combustion waste process water discharges into the west side of the north cell, which is separated from the south section by an earthen dike. The north side of the impoundment is the primary sedimentation area. Decant water flows by gravity to the southeast section of the impoundment through a pipe in the dividing dike. Figure 8.1-1 shows the dividing dike.

Figure 8.1-1: Photo of dike dividing ash pond from clear water pond.
